Temperature Control Self-Storage System

For Roof Pitches 1":12" to 8":12"

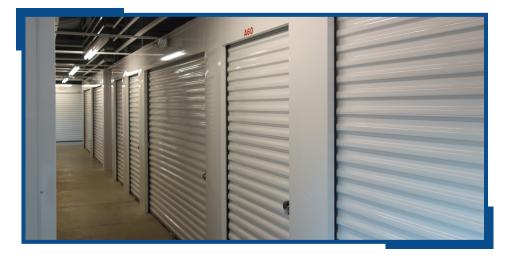
20-gauge bright white flush hallway with louvered headers. Burglar bars are installed to fill gaps larger than 7".

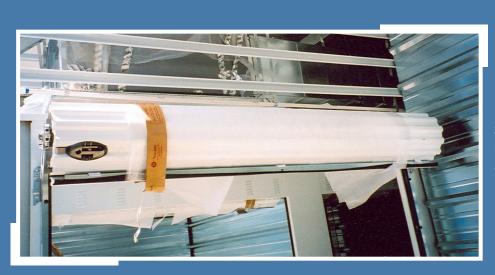
Square duct is located throughout the length of the hallway with vents forcing air into each unit.

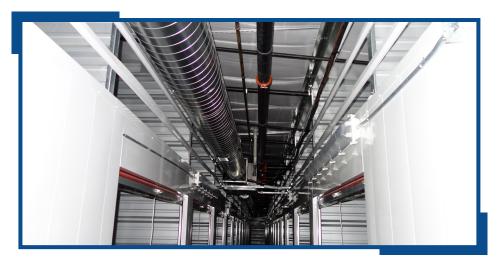
Diffuser is cut into the duct to vent air into the unit. Sprinkler pipes can also be seen in this photo.

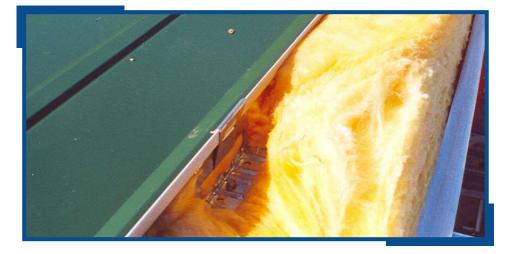
Fiberglass insulation is typical for all climate-controlled buildings. Local energy code may dictate the amount needed. This photo illustrates Trachte's colored standing seam roof, however, a R-panel roof can also be used with this insulation.

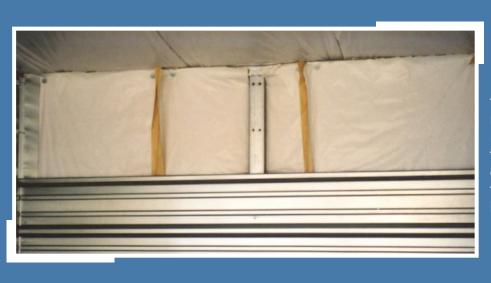
In a climate-controlled building, the wall that separates the climate-control and non-climate control units must be insulated. A 4" R13 insulation is installed on the columns provided. Then the wall is covered with metal liner panel, so that there is no exposed insulation that can be damaged.

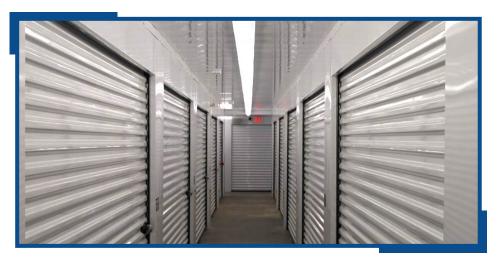
The optional bright white flush ceiling conceals duct work. Lights are then attached to the ceiling. This customer utilized a flush header because some building codes do not allow the corridor to be the cold air return.

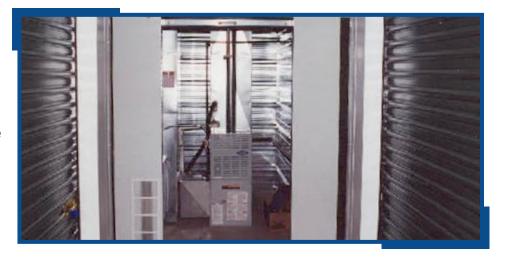
A HVAC unit installed inside a storage unit. May require enclosing unit with fire walls and a fire door.

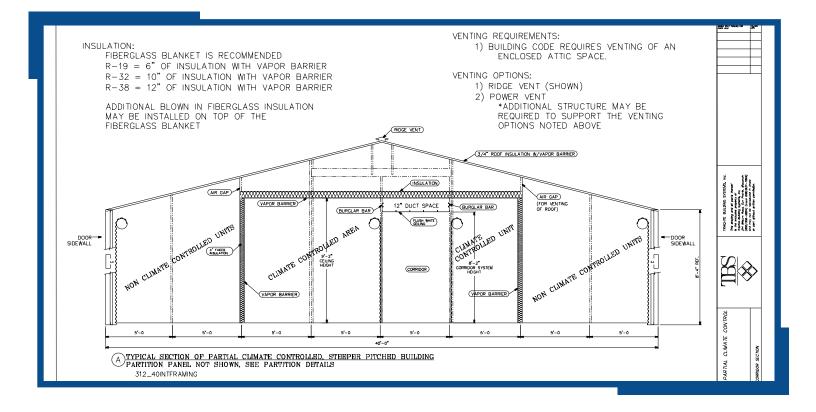
Here is a typical detail of a partially climate controlled building. The units on the exterior are not climate control, the interior units are climate control. The exterior units allow for some ventilation of the attic space. Additional ventilation may be required.

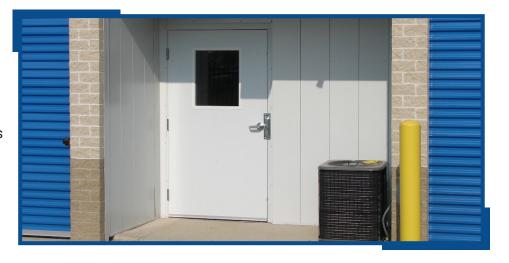
HVAC unit is normally placed inside recessed area. Notice the heating unit is vented out of the same area.

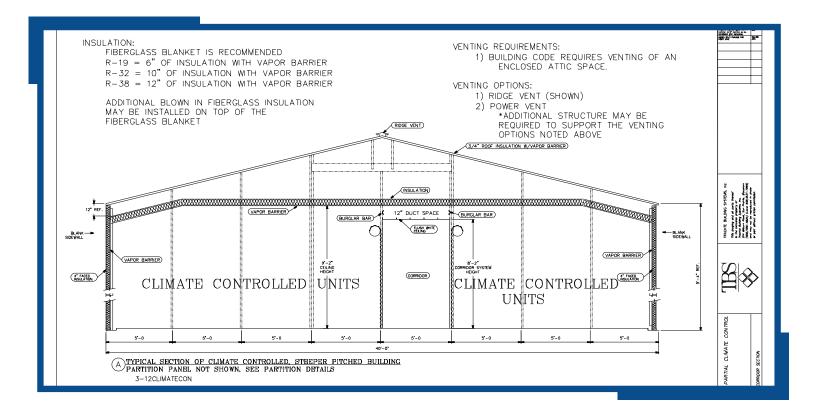
This climate controlled building has no exterior doors, so each unit is climate controlled. This type of building requires the attic space to be vented. The following photos will show options when using ridge vents or power vents, in order to accomplish the air circulation needed to prevent condensation in the attic.

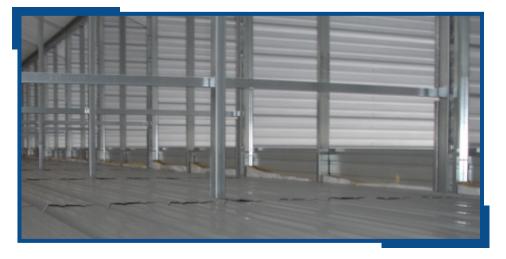
29 gauge galvalume or 26 gauge iced white panel is installed as a ceiling. The panel is typically installed at a height of 9'2".

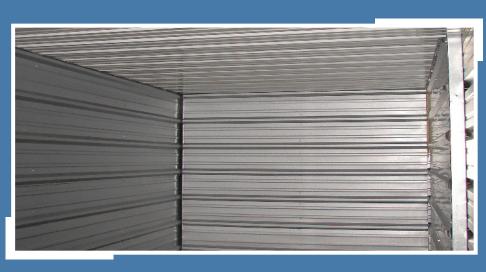
Inside each unit is a metal ceiling.

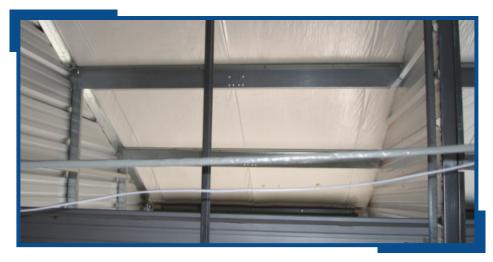
In a partially climate controlled building, there is a large open area to the nonclimate controlled unit in order to receive proper air flow. The exterior door allows for air penetration.

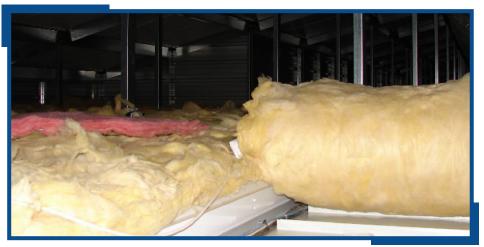
Rolls of fiberglass insulation are rolled out. The first roll should have a vapor barrier or a vapor barrier should be put down first. Additional fiberglass may be added for additional R-value.Blown-in insulation is not recommended since each cut panel around the columns must be taped to prevent the insulation from falling into a unit.

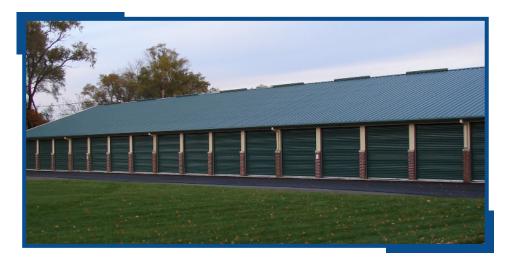
Ridge vents on a partially climate controlled building. The ridge vents are painted the same color as the roof, or may be accented. Trachte offers a limited number of colors.

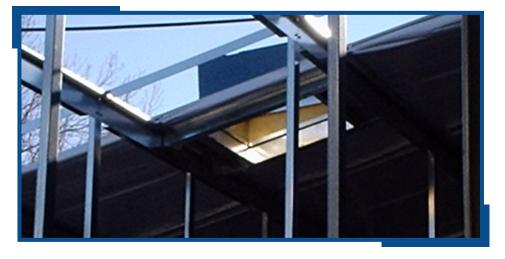
To ensure proper ventilation, it may be necessary to include power vents to ventilate the attic space. Typically there will be two vents, one intake and one exhaust.

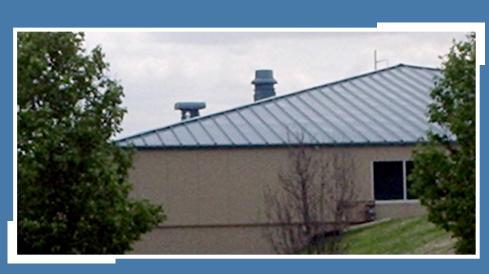
An outside view of the power vents. The owner installed the power vents on the back side of the building so they are not visible from the main road.

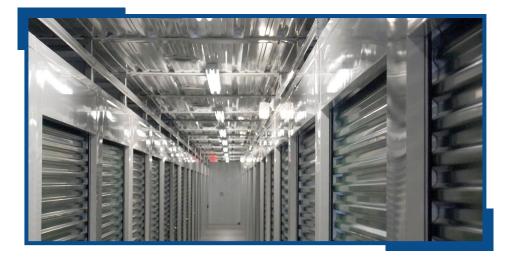
This building has an attic space which contains the ductwork.
